Repair and preventive maintenance of photovoltaic modules with degrading backsheets using flowable silicone sealant

Abstract

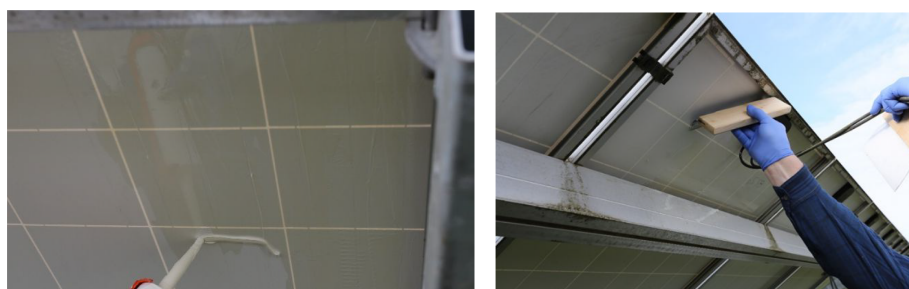
FIGURE 4 Application of the silicone sealant in the field without dismantling the modules

The repair procedure was implemented on a few PV modules in a solar park in Southern Germany. Here the modules were not dismantled but directly coated in the plant (see Figure 4). The silicone was applied from a cartridge and then distributed and smoothed over the whole surface via a broad spatula. The repaired modules were left to operate in the field for about 2 months (April–May–June 2021) after which they were dismantled and transported to the laboratory for measurements: (i) microscopic measurements to check for complete crack filling and surface coverage and (ii) electrical measurements to test for the insulation resistance.

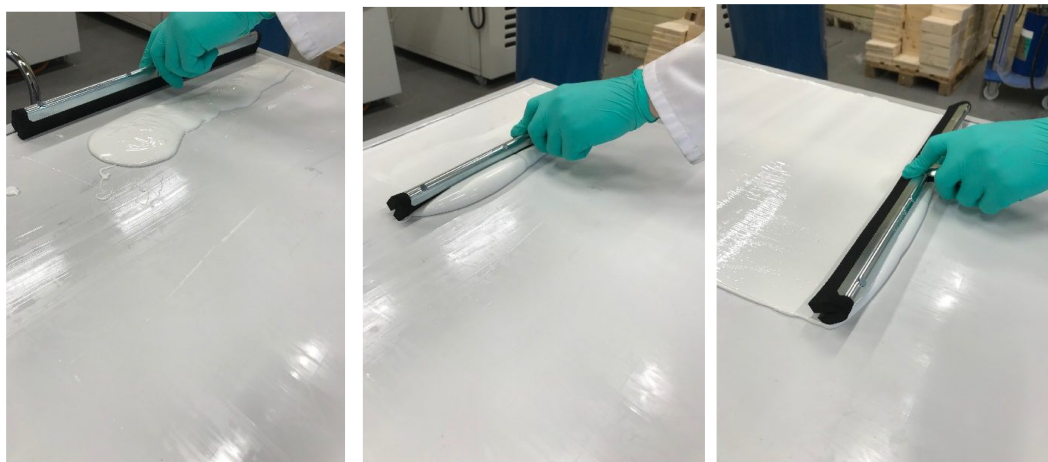
FIGURE 11 Application of flowable silicone sealant on a backsheet using a squeegee

The inclined position, backsheet facing down of a module makes the application of a coating challenging. If the module can be dismounted and placed sunny-side down, the material can be more easily applied and the repair duration can be reduced to a very short time. In Figure 11, we show a convenient procedure in which the material is poured on the backsheet and spread over the surface with a

squeegee. This procedure allows a module to be coated in less than a minute.

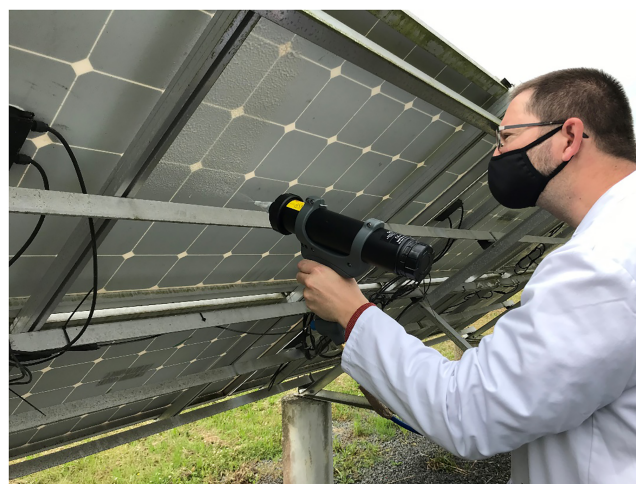
FIGURE 13 Application of flowable silicone sealant without module dismounting by spraying

An alternative, faster application is to spray the silicone sealant onto the back of the module as shown in Figure 13. The flowable silicone sealant is sprayable either with a pneumatic cartridge gun with a spray nozzle powered by compressed air, or with a dedicated system that pumps the flowable silicone sealant from a pail or a drum and drives it through a spray nozzle.

The surface of the silicone material after spray coating is not smooth but shows little hills and valleys. For best coating quality, smoothing with a spatula is recommended. It not only leads to a better coating uniformity but also helps pushing the sealant into the cracks.
